## 1. Background

A 250MW CA Parsons turbine IP cylinder was opened for inspection and severe shroud separation was found in the rotating as well as stationary blade shrouds. The norm is that this case would be a total re-blade of the cylinder. This was not possible due to spares availability, cost and expected life of the plant.

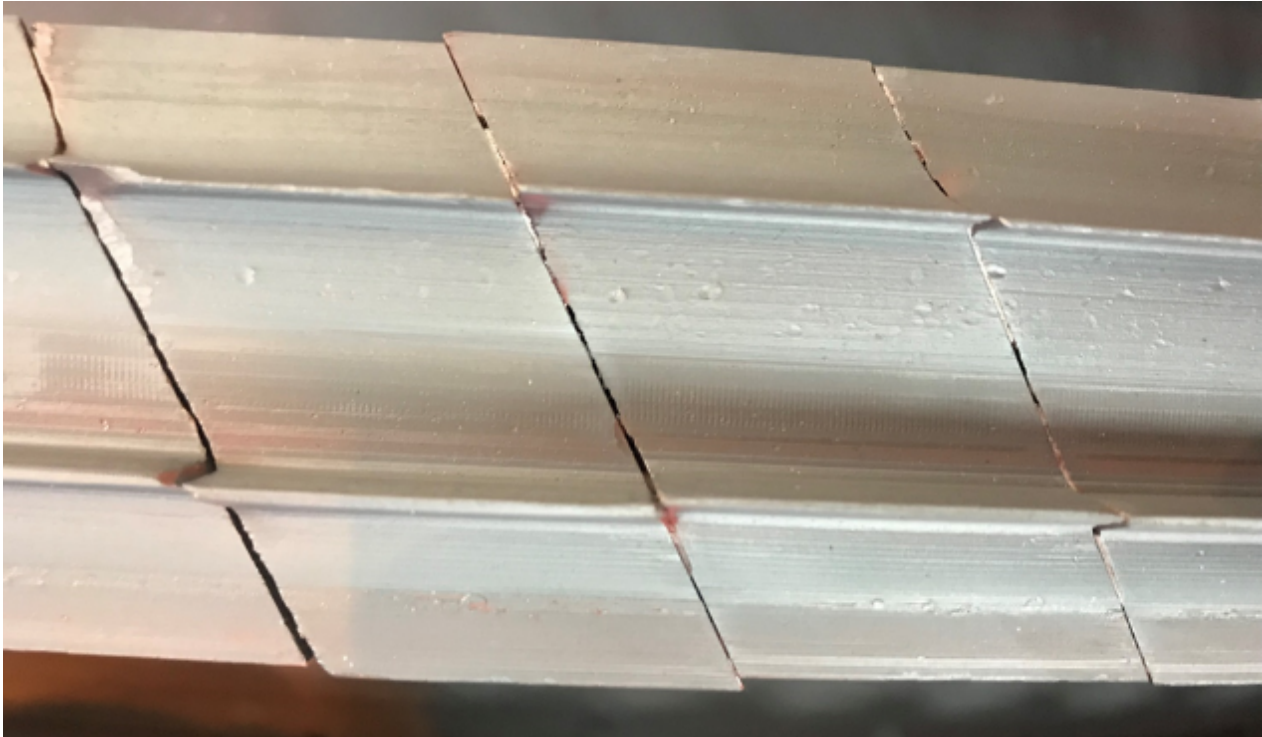
Blade shroud separation is the phenomenon describing the loss of the blade to blade shroud connection of blades in a packet. This connection is required for the damping of vibration and reducing the stress in individual blades. Without this connection the risk of blade failure is high. The picture below shows blades separated and also shrouds moving relative to each other. This could be described as early symptoms of eventual failure.

Figure 1 Blade shrouds separated by the loss of the original brazing connection

ProGen proposed a weld repair of the blade shrouds to the design packet configuration. Such welding has been done before elsewhere in the world but not to the extent required on this unit nor has it been carried out in New Zealand. What made this more challenging was that it had to be done without any involvement from the OEM.

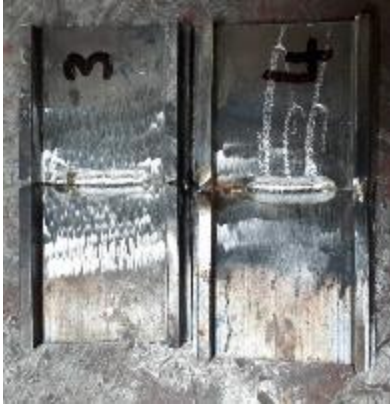
Figure 2 Test pieces prepared for welding

In preparation for the shroud welding, test pieces of the same material and geometry as the blades were prepared to qualify the weld procedure and welders to ensure it could be done to the required standard. The test pieces were made as representative as possible by brazing them together and positioning the excavation and weld to simulate the repair done to the blading on the rotor and also in casing.

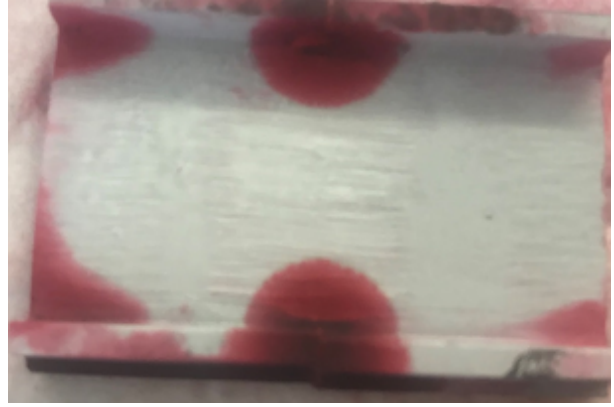
Figure 3 Successful repair of a test piece

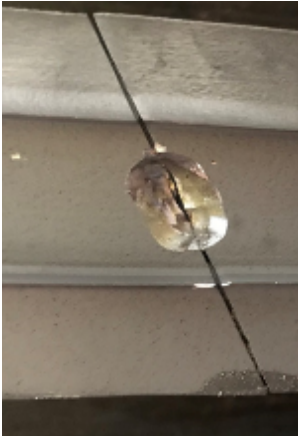
Figure 4 Weld preparation

- The blade packets were identified and marked, together with all of the identified separations to be weld repaired.
- The weld preparation was completed, and the rotor cleaned.
- Preheat, Welding, NDE was done on a batch basis as described by the following figures

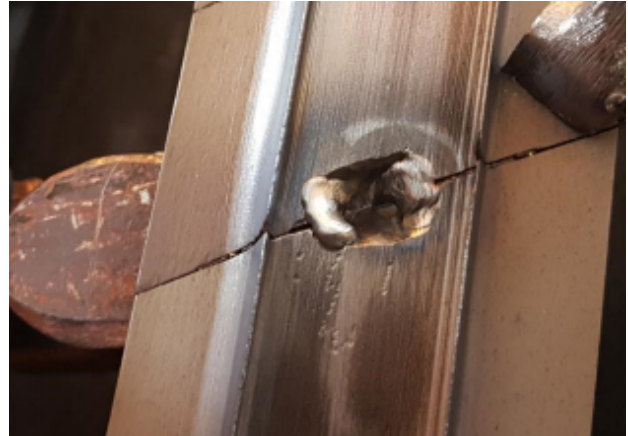
Figure 5 Weld root

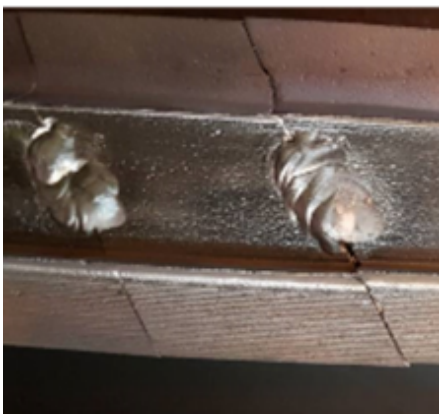
Figure 6 Completed welds

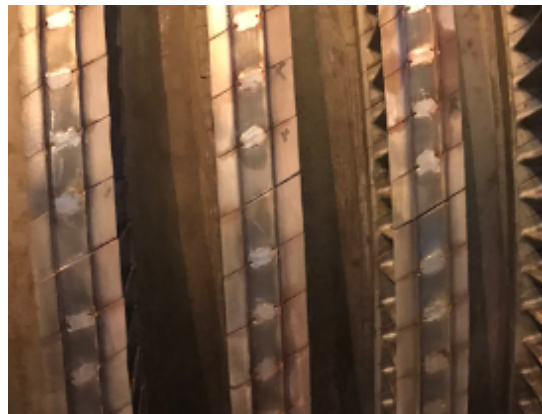
Figure 7 Rotor shrouding worked down
