Case study: Recovery turbine blade shroud separation

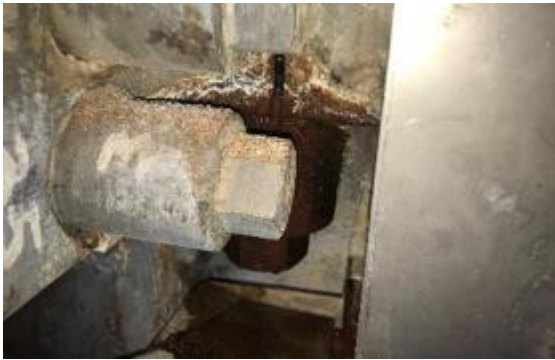
The 17MW Geothermal steam turbine had been operating for many years with a leak in the casing half joint. The leaks that were at the same position on both sides of the casing could be traced back three outage cycles and each time an attempt was made to resolve the leak.

Figure 1 Casing half joint leak in operation

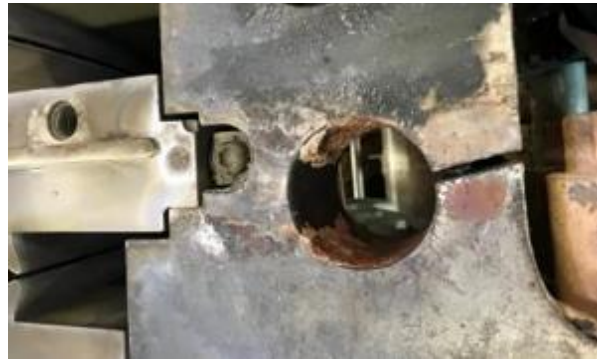
Figure 2 Leak position in the bottom casing

Clear evidence was found that steam leaked through the half joint from the diaphragm circumferential slot to the bolt hole as shown in Figure 2. With the casings cleaned and bolted together the contact blue check revealed contact in the area of the leak as was also reported during previous outages. A surface plate blue check was done and the result showed that the joint was not 100% flat in the unbolted condition with the leak area showing no blue contact. This gap was however very small and no gap could be measured with the casings in the unbolted condition assembled. This indicated that the casing was deformed during bolting to make contact and that the contact was not constant along the half joint surface.

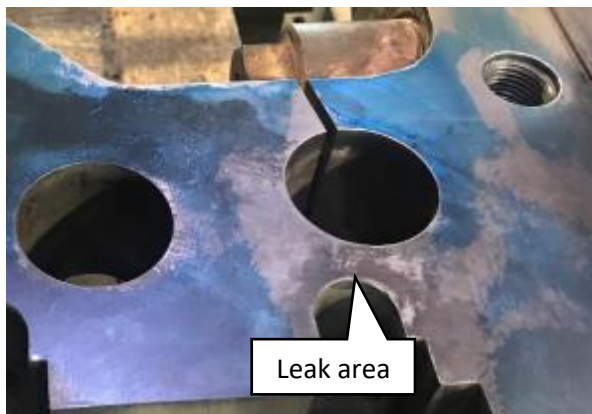
Figure 3 Surface plate blue check result

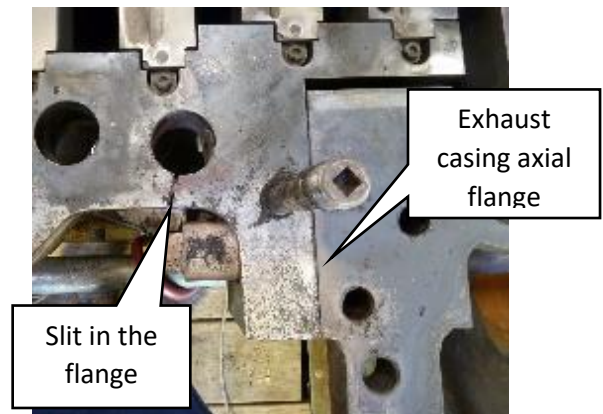
Figure 4 the exhaust casing flange and interface

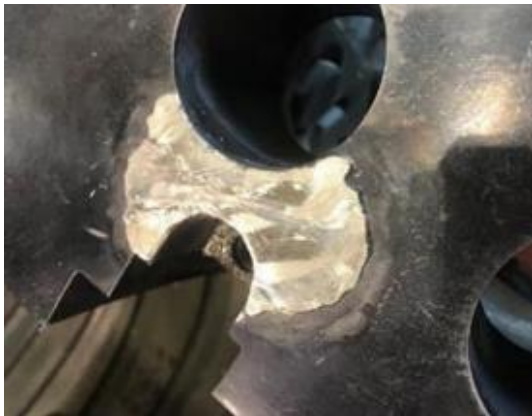
Figure 5 The leak area build up with Brazing

1. the leak area was brazed up and worked down to the same level as the surrounding surface;
2. following this, a surface plate and scraping was used to ensure the mating surfaces were 100% flat for both casing halves;
3. the casing was then scraped to improve the leak prone area clamping force according to the analysis;
4. for the re-build, a customised bolting procedure was devised to ensure maximum clamping force of the joint while staying within the bolt tightening specifications; and
5. the joint sealant was changed to a compound more suitable for the specific casing and the bolting procedure.

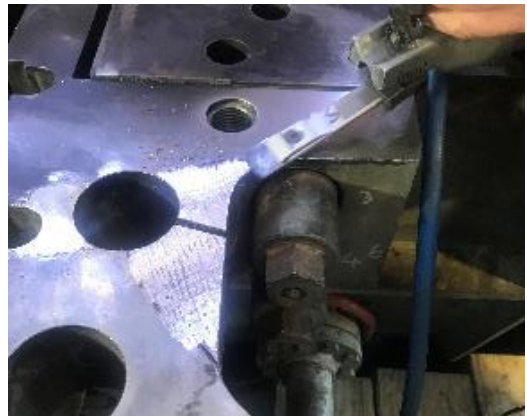
Figure 6 Scraping of the casing to improve clamping

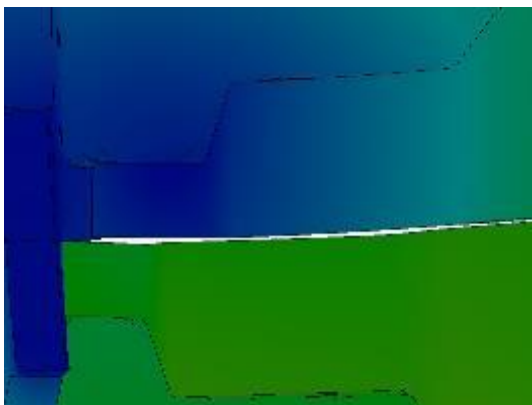
Following the outage ProGen carried out an FEA study on the casing that determined the behaviour from the cold-bolted condition to the hot operational condition. The results compared remarkably well with the analysis done during the outage and it proved that the actions taken during the outage were correct to address the problem.

Figure 8 FEA results showing an opening force

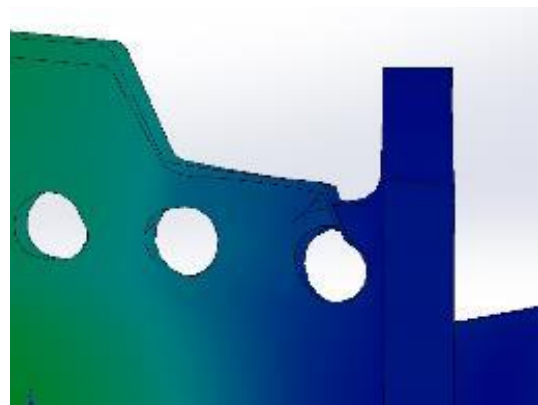
Figure 8 FEA results showing axial the distortion
