# **100MW Geothermal Steam Turbine Case Study**

**Jan-Feb - 2018**

## EXECUTIVE SUMMARY

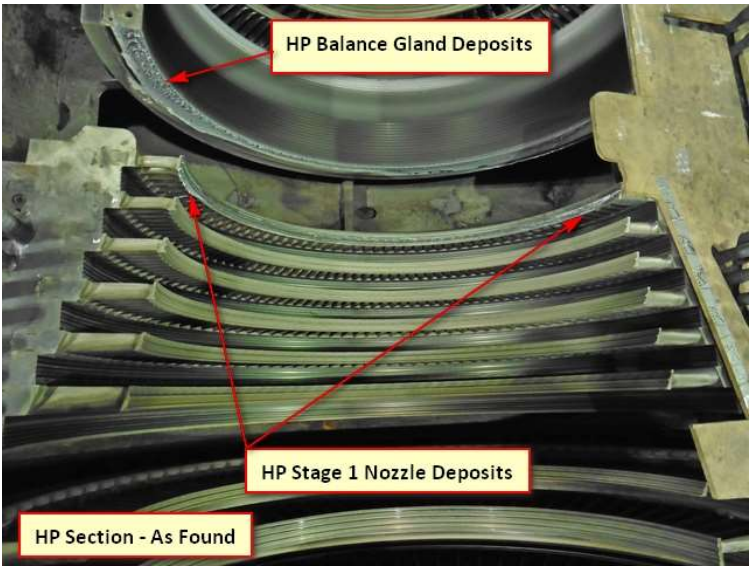
Picture above showing general condition of the lower cylinder HP steam path

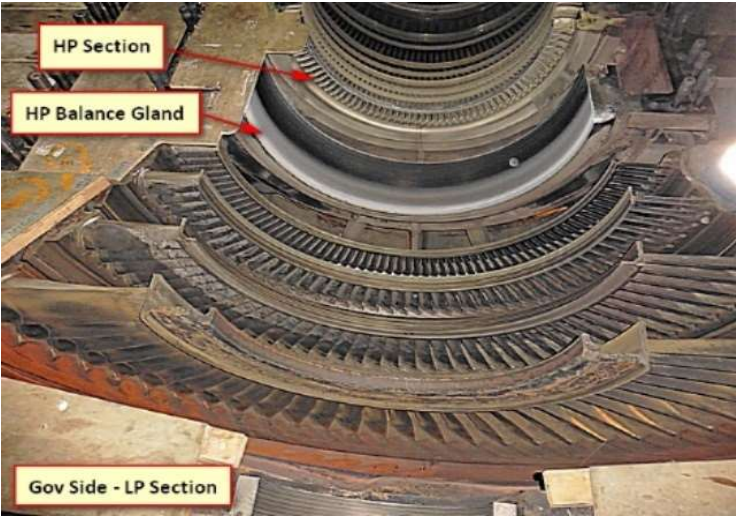
Picture above showing the general condition of the LP steam path (Gov Side)

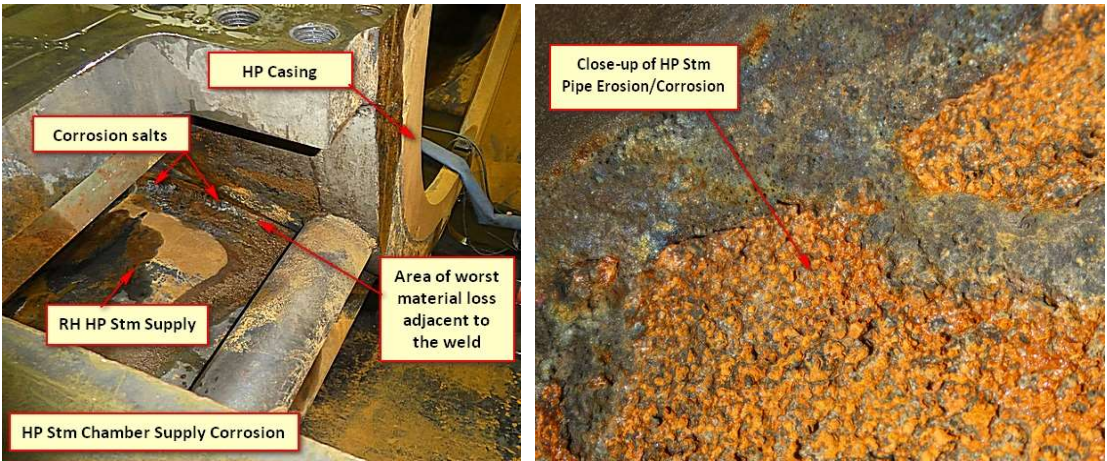
Pictures above and below of the HP Steam Inlet pipework showing erosion and corrosion.

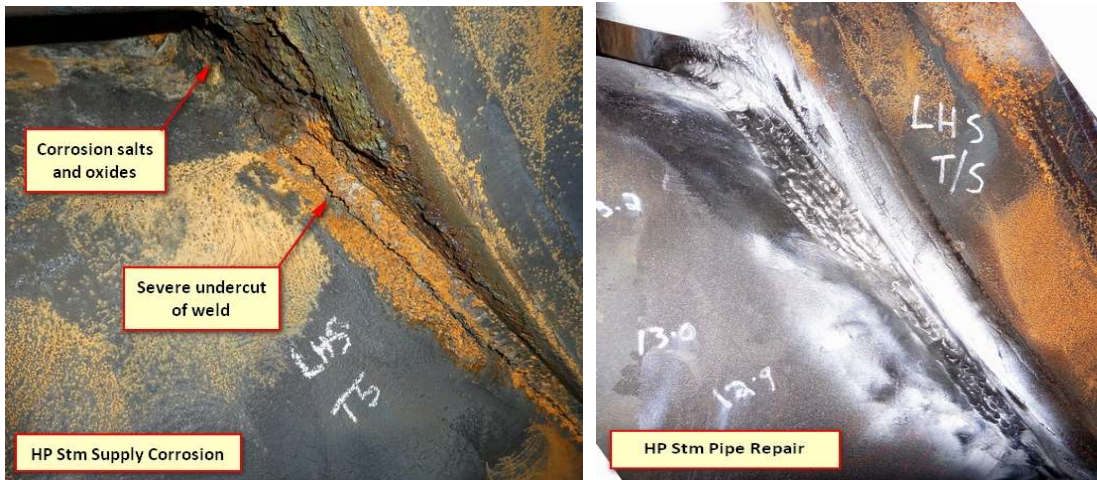
Pictures above showing the damaged HP steam inlet pipe before and after repairs

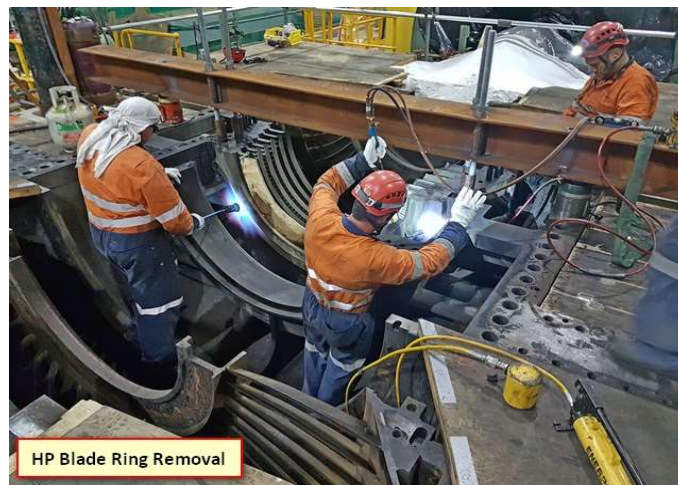
Picture of set-up for the removal of the lower HP Blade Ring

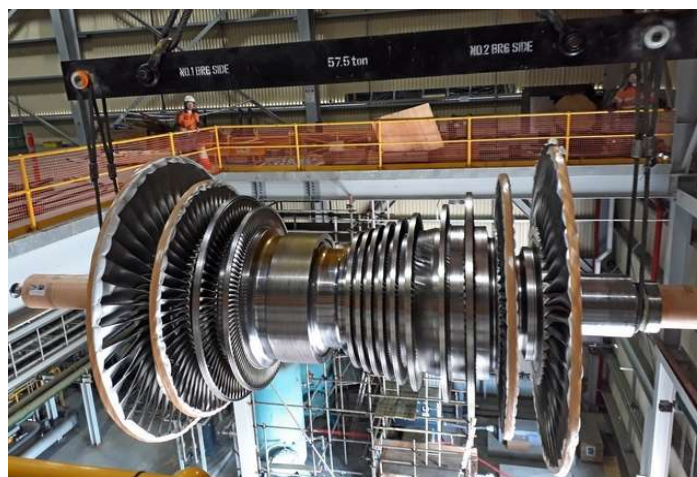
Picture of the new turbine rotor being lifted to the turbine deck with conventional rigging.

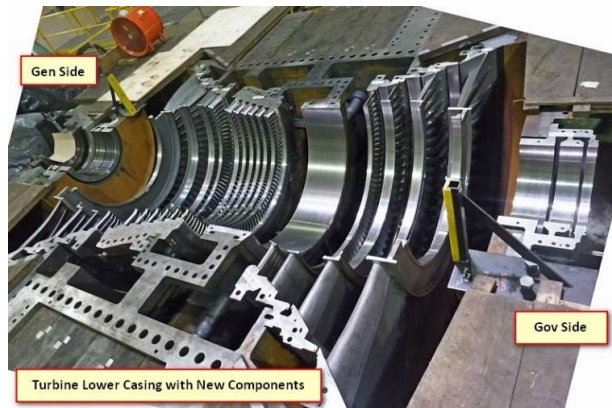
Picture of the turbine lower casing with new components installed

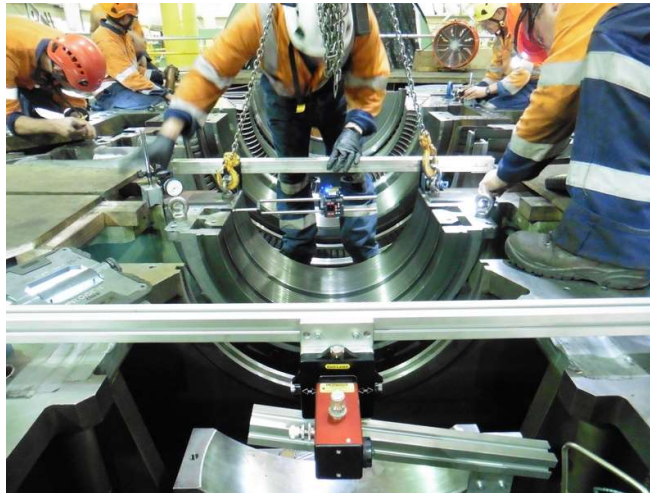
Final positioning of LP gland seals before tightening.

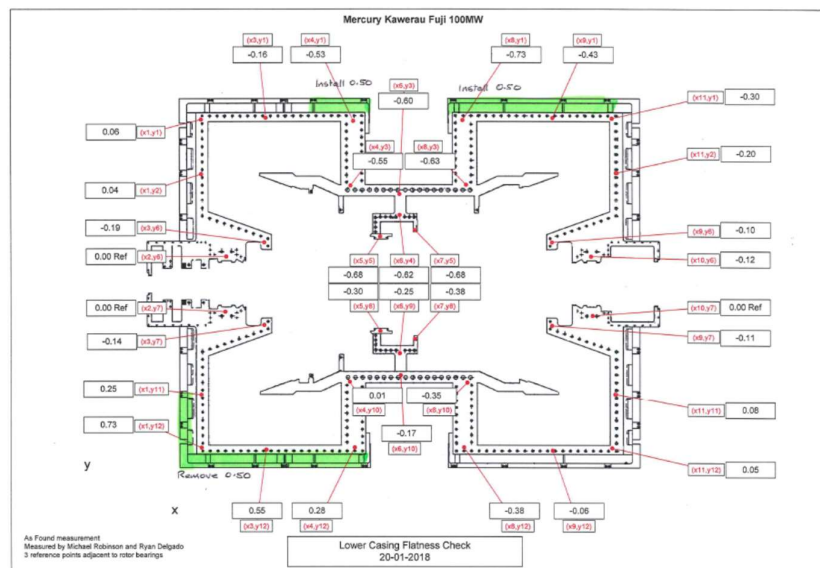
The As-Found flatness check turned out to be not optimal. The casing was shimmed according to instructions of the OEM as outlined in the chart above. In summary, 0.50mm was removed from the RH Front exhaust limb and inserted in the LH Centre pads. (Green highlight).
