320MW Thermal Steam Turbine – Case Study

2016 - 2019

320mW STG

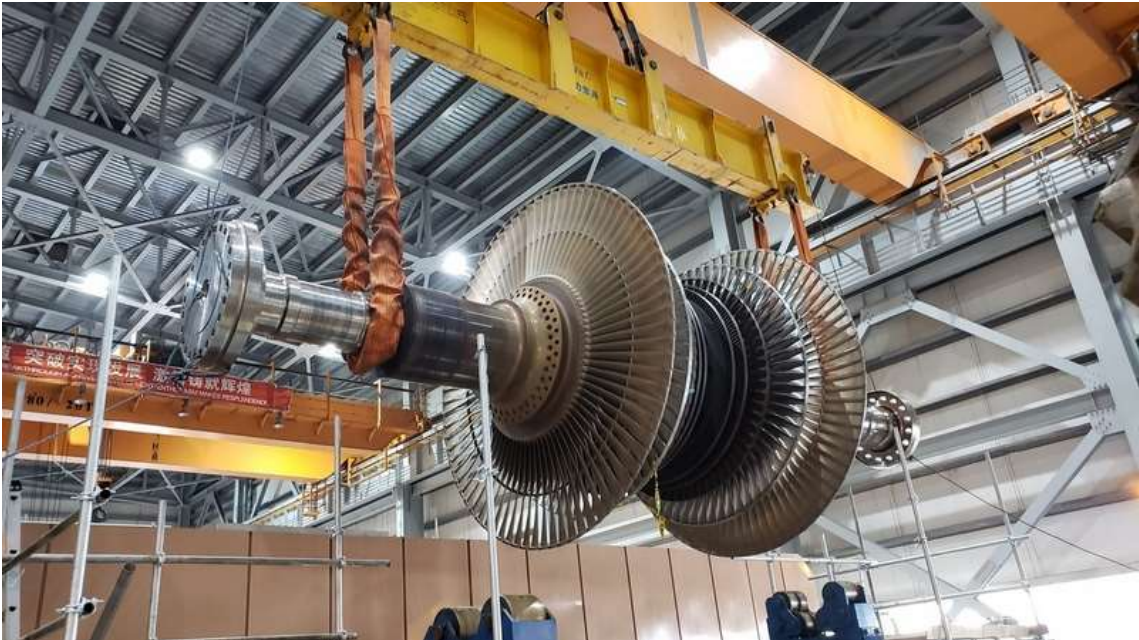
Turbine LP rotor repositioning after reblading.

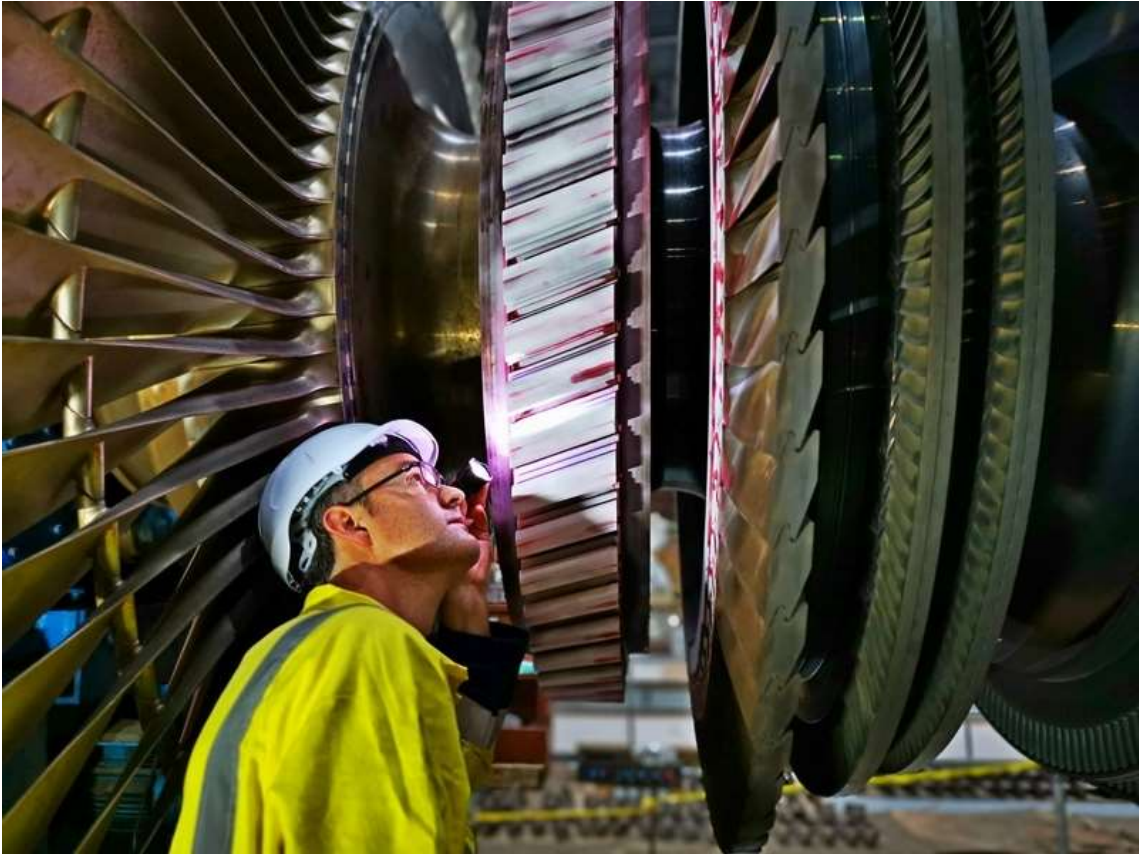
Row L-1 blade root inspection – Prior to reblading

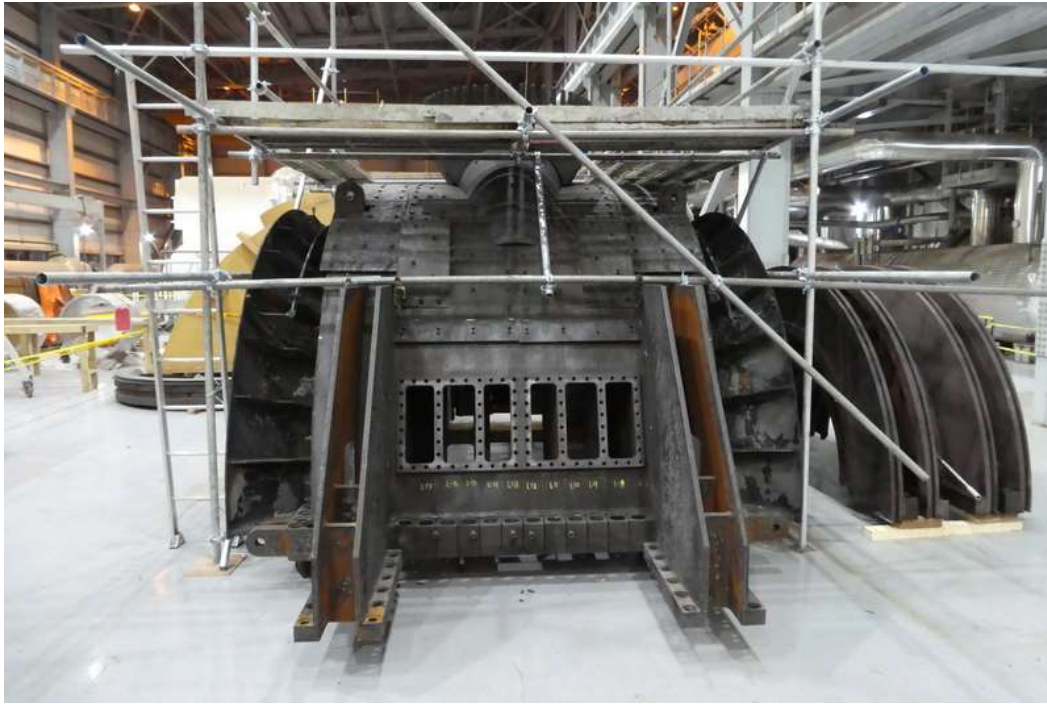
LP Inner Cylinder

- There have been reported issues with vacuum leakage around the gland sections of the LP cylinder. The LP cylinder was removed for inspection so the half joint was able to be inspected for evidence of leakage. The joint area had been generously covered with red RTV gasket sealant. This sealant coverage looked to be secure with only a small area tainted with penetrating oil that would have been used during the removal of difficult bellows bolts. The gland housings were not disturbed during the inspection however it was noted that there is considerable clearance on some of the outer segments, both radially and at the butt gaps of the adjoining segments

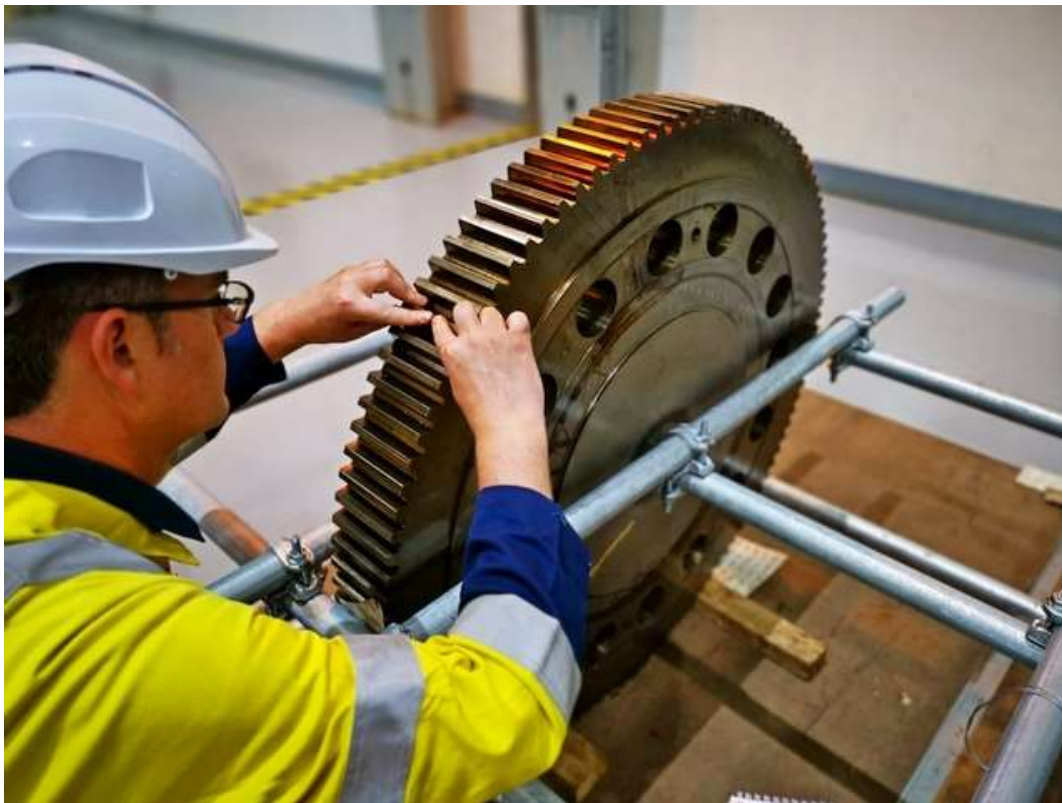
Turning Gear bull gear inspection

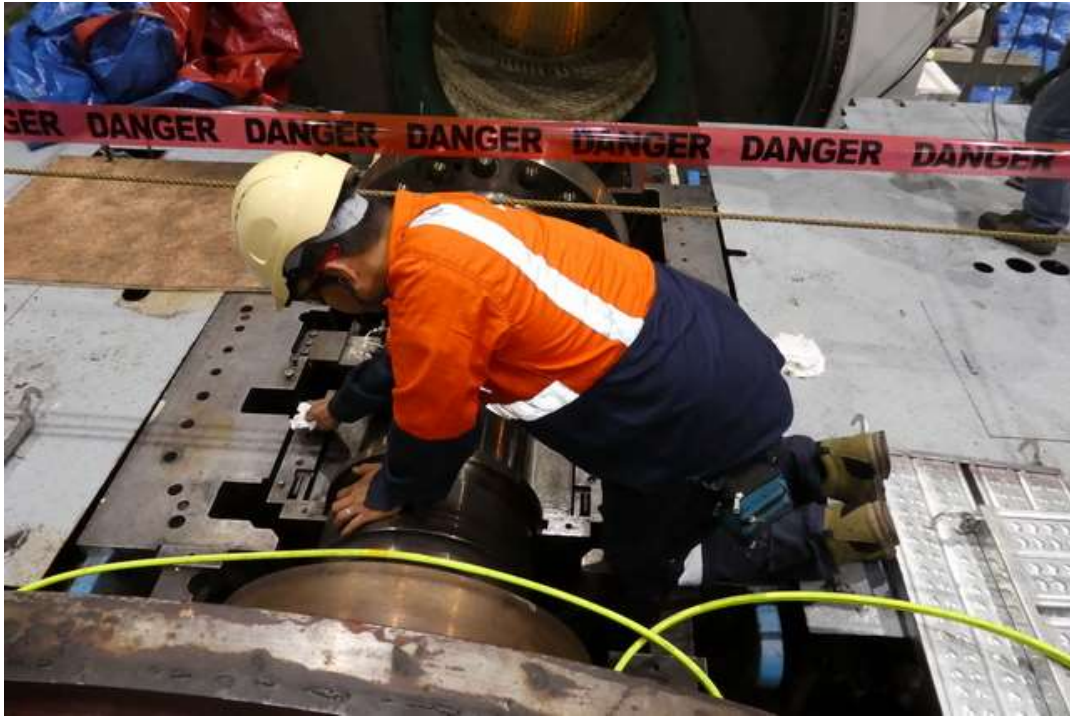
No4 Bearing Reassembly inspection

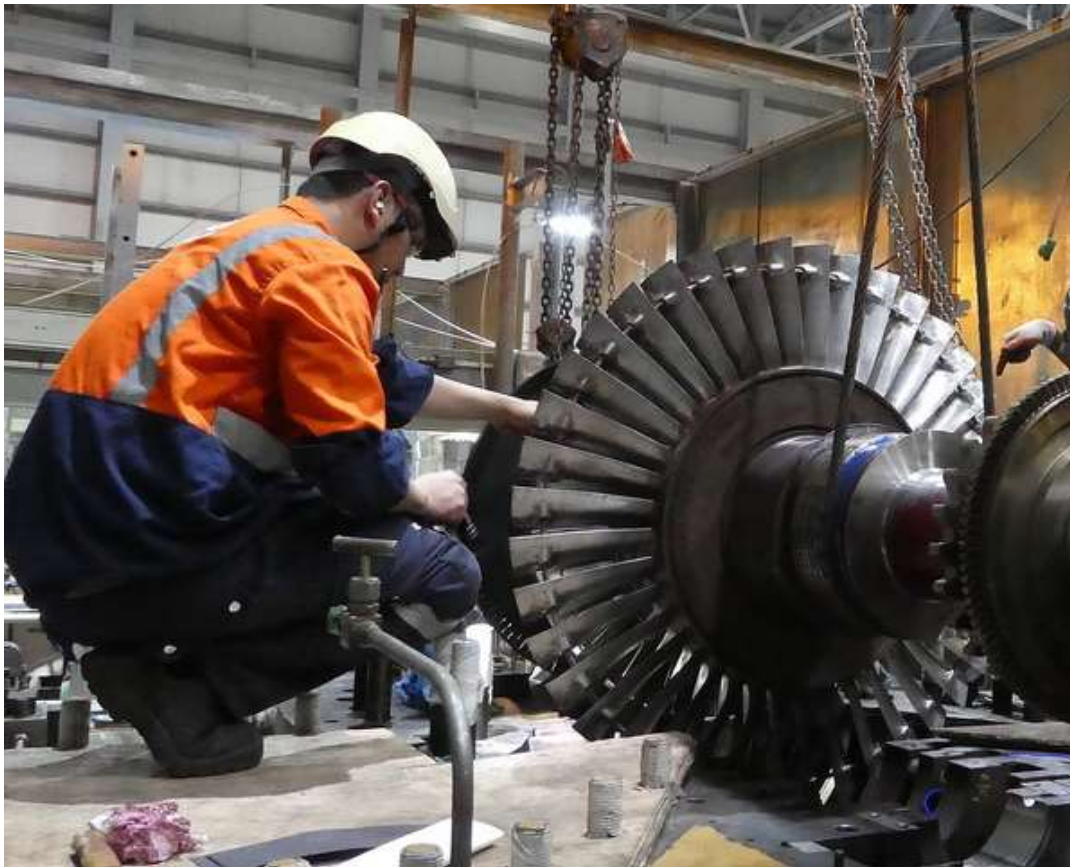
TBFP Rotor installation
