# **400MW Combined Cycle Plant Steam Turbine and Generator Overhaul Case Study**

**Oct-Dec - 2018**

<i>Case Study</i>	:	Project 1463
<i>Prepared by</i>	:	Alan Robinson / Brett Houston
<i>Date Issued</i>	:	May 2019

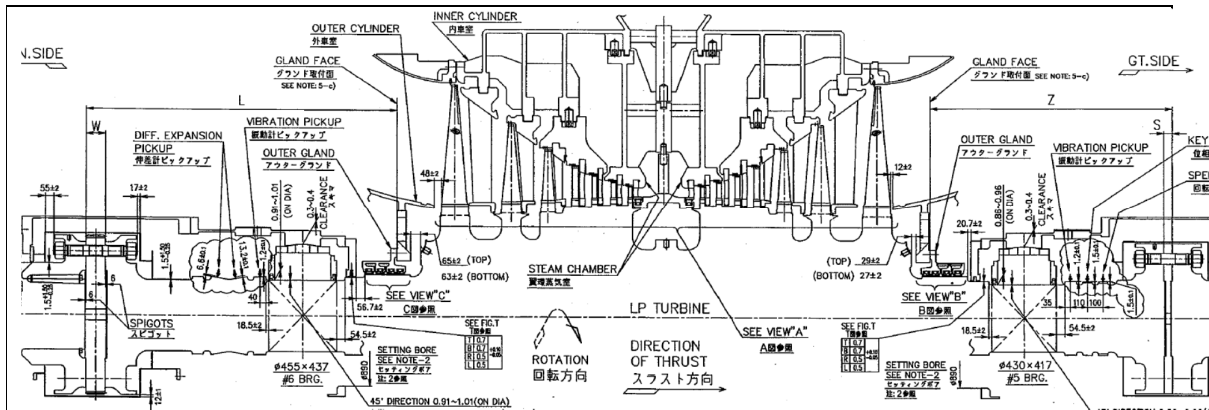
## LP TURBINE

- The LP turbine was disassembled. The upper and lower steam chamber, internal blade rings and glands were removed for inspection.
  - o All internal operating clearances and datums were recorded during the dismantling process.

- o LP rotor cleaned and inspected for wear, corrosion to blading, other damage to erosion shields and seal surfaces
  - o Rotor journals measured for wear and then restored to operating condition to remove any glazing.

- o The turbine bearings were inspected, NDT'd and cleared for reinstatement.
  - o Coupling surfaces checked for unusual conditions, bolt holes cleaned, burrs removed and dimensions checked.

- o The LP turbine casing was cleaned and prepared for reassembly. Some of the crossover studs were required to be replaced
- The LP cylinder was reassembled following acceptance of the condition and operating clearances.

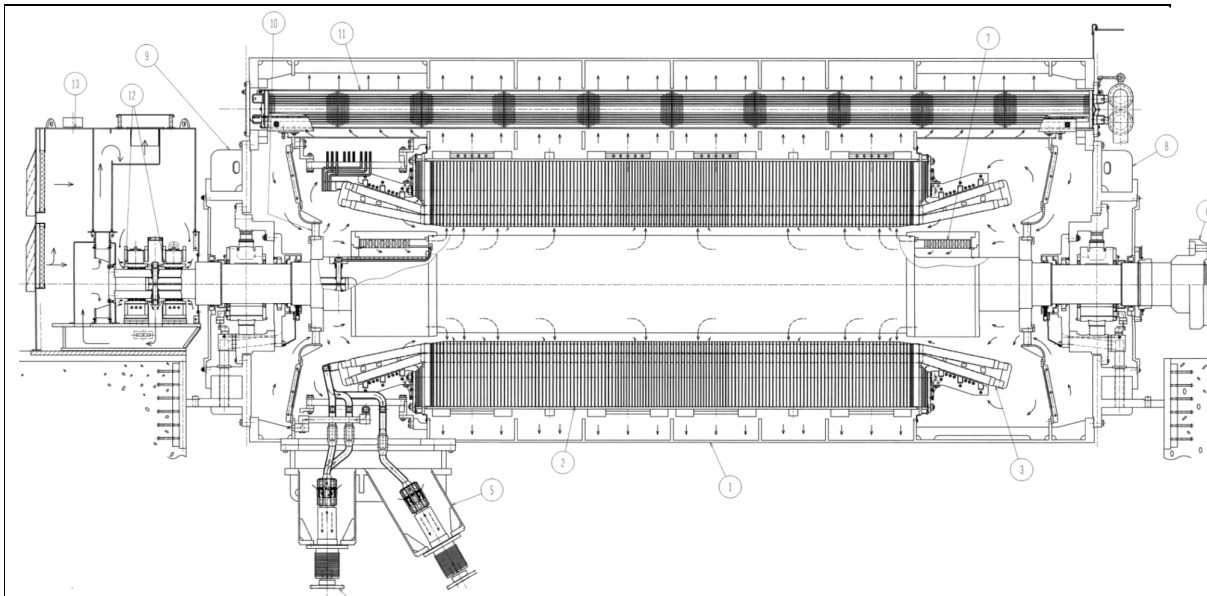
## GENERATOR

- The generator rotor was removed for a scheduled inspection. The excitation slip ring housing and brush-gear was removed for electrical assessment and refurbishment.

- The bearings were removed for inspection and NDT then prepared for reinstatement during the reassembly process. The rotor journals were measured/inspected for wear and condition. The journal was cleaned to remove the glaze.

- The hydrogen seal components were removed, inspected and NDT'd. The H<sub>2</sub> seal components were found to be in good condition and required limited cleaning.

- The end door brackets and bearing carrier components were cleaned and prepared for reassembly.
- The H<sub>2</sub> cooler waterboxes were removed for inspection. The tubes were cleaned and inspected for corrosion. The waterboxes required some minor coating repairs.
