1. Background

The 20MW organic Rankine cycle bi-turbine units were suffering from a higher than expected bearing failure rate. The alignment of the turbines to the generator is considered one of the primary possibilities why the bearings failure rate is higher than expected. The distortion of the turbine structure due to the exhaust pipe movement was suspected as contributor to the bearing failures due to the impact on alignment with the generator.

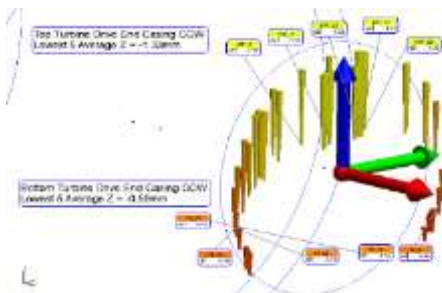
The vertical movement of the drive and non-drive end of the turbine due to thermal expansion results in an angular-vertical movement of the centreline relative to the generator that is more than the specified alignment tolerance.

Figure 2: Turbine drive end vertical movement

The analysis showed that the casing support below the centreline with the casing warmer on the drive end than the exhaust end, result in the drive end expanding more, causing the shaft and coupling to move upward and to an angle relative to the generator.

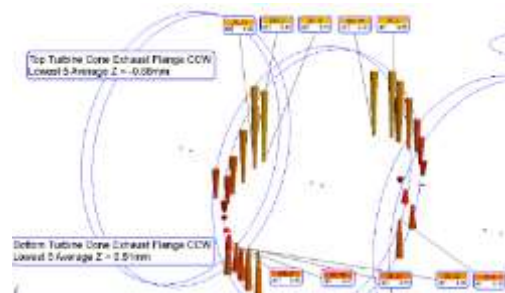
Figure 3: Turbine exhaust end movement

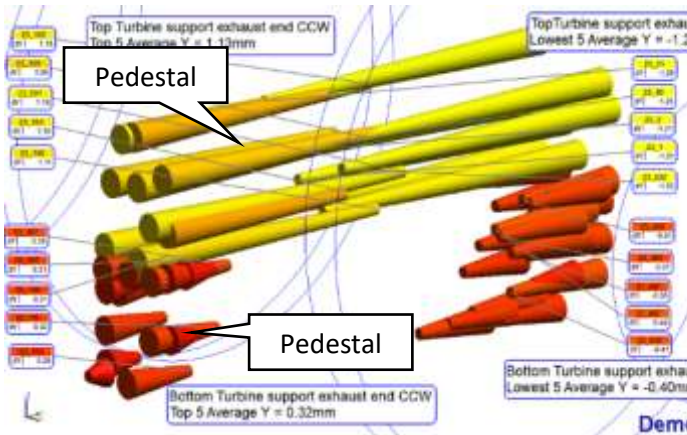
Thermal expansion movement of the turbine casing on the support structure caused the structure to distort in the direction of the expansion movement. The distortion was found to be inconsistent and asymmetric. This is a negative scenario the support structure is subjected to undesired stress and it results in movement of the centreline and changes in the alignment.

Figure 4: Movement in the transverse direction

The specified set-up of the palm supports was found to cause high levels of friction between the turbine casing and the pedestal palms causing the abnormal distortion.

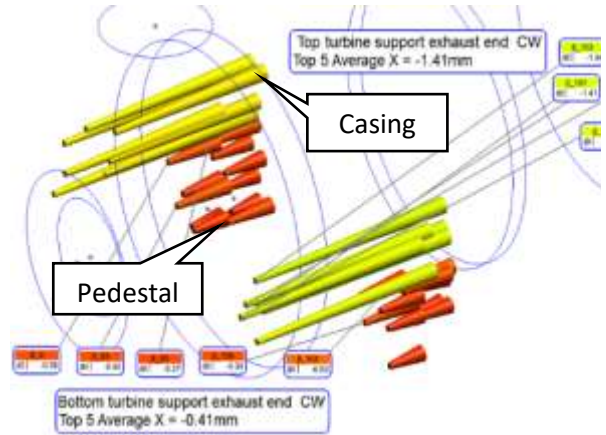
Figure 5: Movement in the axial direction

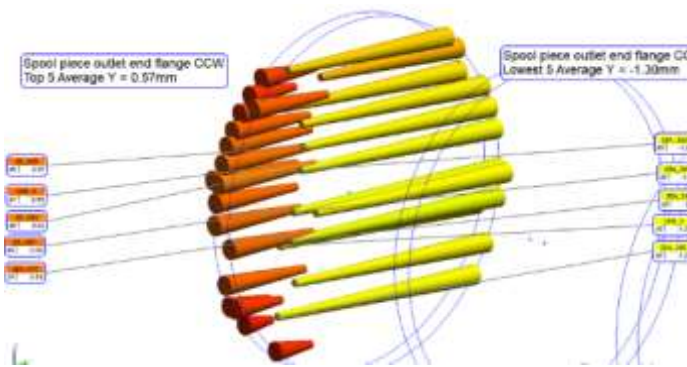
Although the design of the exhaust pipe assembly incorporates features that should allow free movement of the pipework relative to the turbine structure, there is clear evidence of force being transmitted to the turbine structure resulting in movement of the turbine and distortion of the turbine exhaust. This movement had a direct influence on the alignment of the turbine to the generator.

Figure 6: Sideways movement of the turbine exhaust

The amount of and types of distortion measured is an indication of the severity and magnitude of the exerted forces.

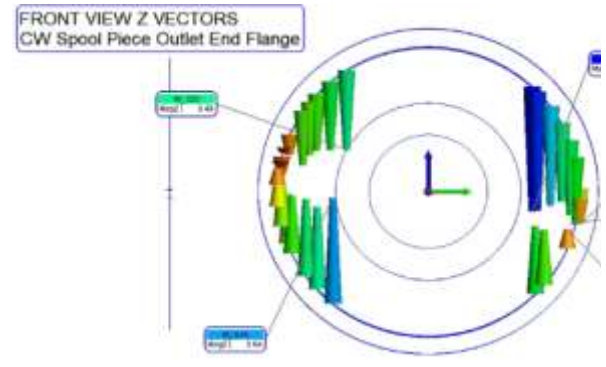
Figure 7: Oval distortion of the turbine exhaust

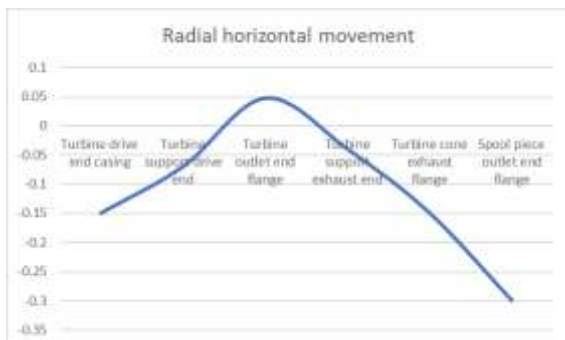
One turbine casing was found to bend going through the transient from cold to hot. The bending was caused by the asymmetric temperature distribution of the casing. The cause of this phenomena is due to the internal flow of pentane. The distortion affects the centreline movement and the alignment to the generator and can also result in turbine performance and reliability problems.

Figure 8: Bending of the turbine casing due to asymmetric thermal expansion

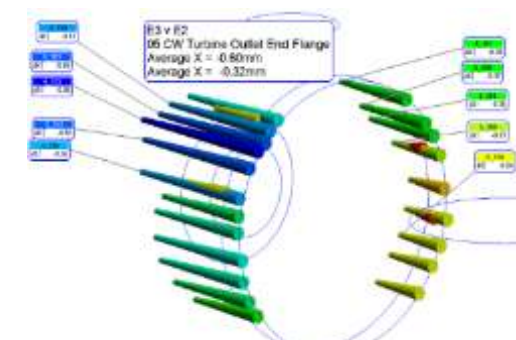
Figure 9: Asymmetric expansion of the casing
