# FLATNESS SURVEY AND CORRECTION OF TURBINE-GENERATOR ALIGNMENT USING LASER MEASUREMENT TECHNIQUES

Michael A. Robinson<sup>1</sup> and H. Brett Houston<sup>2</sup>

<sup>1,2</sup> ProGen Ltd, 2/829 Heaphy Terrace, Hamilton, New Zealand 3240

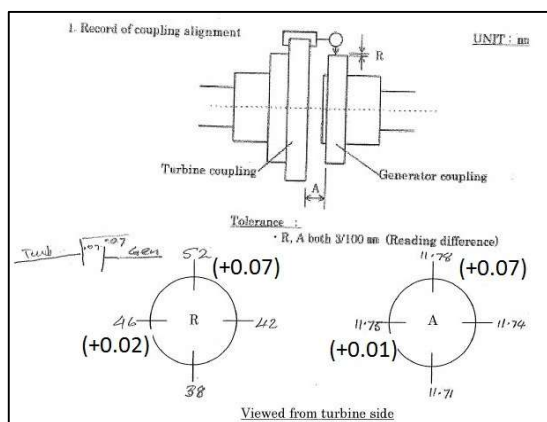
Figure 2: As-Found Shaft Alignment<sup>3</sup>

As-found shaft alignment measurements showed that: the turbine coupling hub was higher than the generator hub by  $0.07\text{mm}$ , and the coupling gap was open at the top by  $0.07\text{mm}$ ; against targets of  $0.00\text{mm}$ . The coupling gap figures, regarded alone, would seem to indicate that either the front of the turbine or the rear of the generator should be raised by approximately  $0.5\text{mm}$  to correct this gap. Lifting the front of the turbine would partially correct the height offset of the turbine coupling hub; whereas lifting the rear bearing of the generator would exacerbate that issue, and require lifting both front and rear generator bearings significantly.

Previous inspection records showed that realignment of the TG had been conducted during past overhaul work, so these measurements were only be used for an indication of the as-found state of the unit. Calculations for final shaft alignment adjustments were based on measurements conducted after the turbine casing had been shimmed.

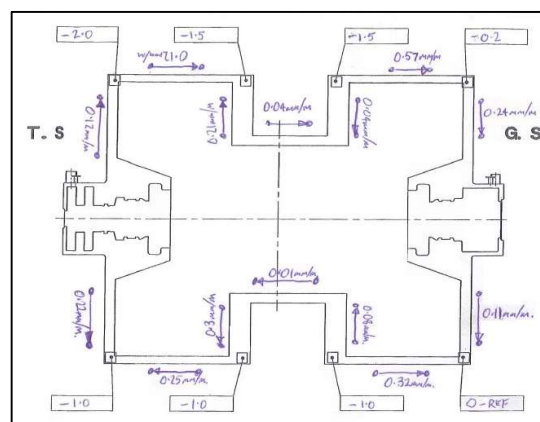
Figure 3: Optical and Spirit Level Measurements (3)

The measurements taken with the optical level indicated that the left front corner of the casing was lower than the right rear by about 2mm. Spirit level measurements showed that the area of #1 bearing could be even lower.

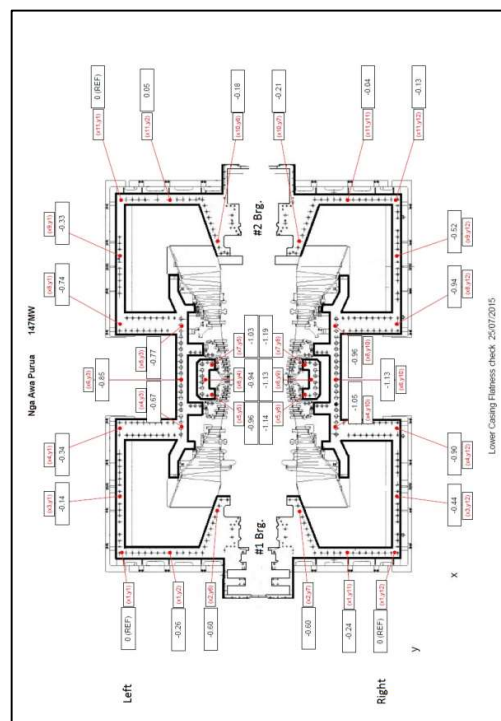
Figure 4: As-Found Lower Casing Flatness<sup>3</sup>

The measurements showed that a general bow shaped depression existed along the length of the casing. The maximum depression was in the region of the centre right of the casing with approximately 1.2mm maximum magnitude.

There was also a depression along the width of the front of the casing in the region of the #1 bearing, with approximately 0.6mm maximum magnitude.

The current method used to set the diaphragm heights is to adjust them level with the half joint face of the casings. This method assumes that the casing is flat and level. So, considering that the internal seal clearances are in the order of 0.3 – 0.4mm, it is clear that with a depression of up to 1.2mm along the length of the casings there was a high risk of diaphragm seal contact with the rotor.

It was decided that the turbine lower casing would be shifted nearer to true level, and that the depressions would be flattened out simultaneously. This would be achieved by lifting the left front of the turbine by about 2mm, and the right front by about 1mm. The rear corners would not be disturbed.

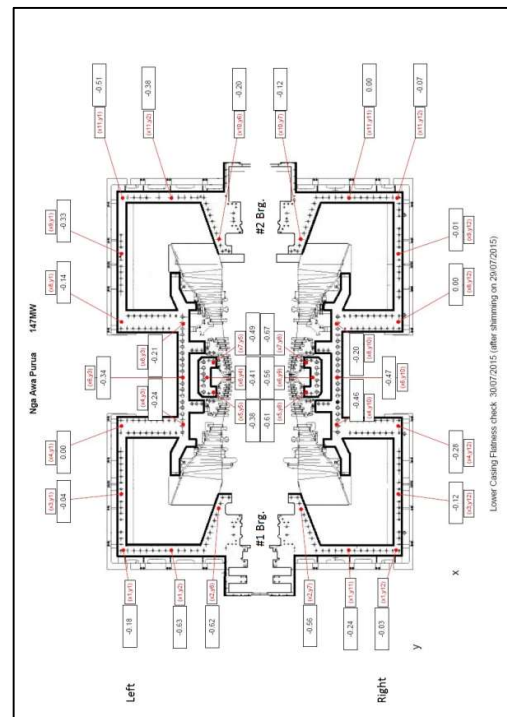
Figure 6: As-Left Lower Casing Flatness<sup>3</sup>

The results presented in Figure 6 are displayed as 'all negative'. The highest points have changed: from three of the corners previously; to two points near the middle of the sides, and one point near the right rear corner. It can be seen that there is less variation in the measurements; i.e. the turbine casing is flatter. Due to time pressure only one attempt at flattening the casing was made. Given at least one more shim alteration, it would have been possible to flatten the casing even further; potentially to within 0.3mm variance.

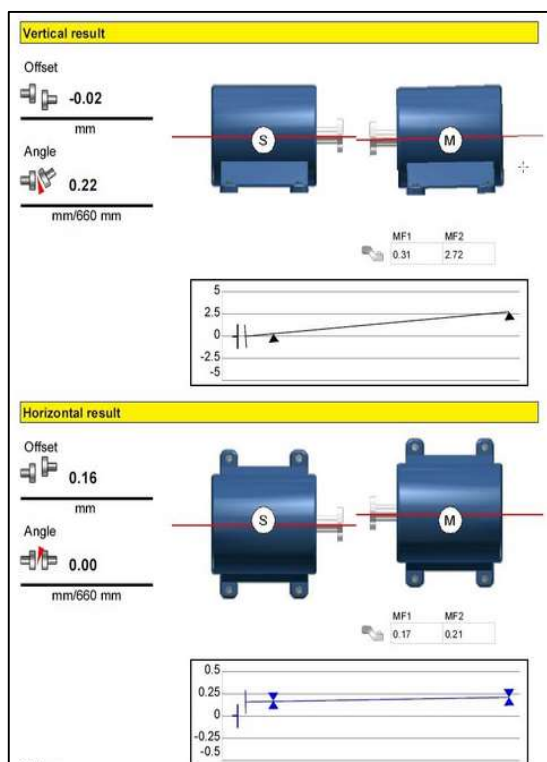
Figure 7: Shaft Alignment after Casing Shimming<sup>3</sup>

Initial results showed that the coupling gap was open at the bottom by 0.22mm. This is consistent with records showing that the generator had been raised significantly at the rear; probably unwittingly accounting for the turbine casing subsiding at the front.

Since the turbine casing was by this time relatively level, it was planned to lower the rear of the generator by about 2.7mm to correct the alignment.

Adjustments were made to the generator in the vertical and horizontal directions, bringing the alignment back within tolerance.

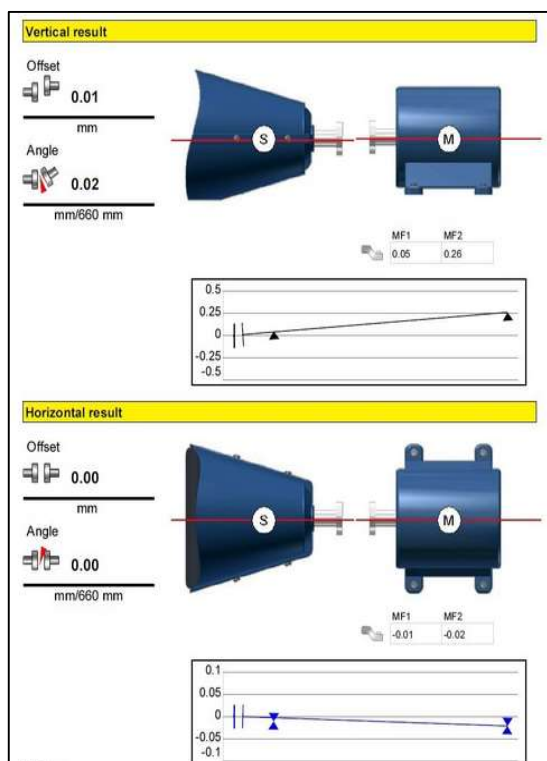
Figure 8: As-Left Shaft Alignment<sup>3</sup>

It is interesting to note that: based on the as-found alignment results, the rear of the generator could have been lifted by approximately 0.5mm to correct the shaft alignment as it was at that time. This action would have addressed only a

symptom of the plinth movement that had been occurring. The final approach taken has been to address the issues at a slightly deeper level; where the root cause of the misalignment has been tracked back, and an effective and efficient solution implemented.
