# WAYANG WINDU POWER STATION TURBINE ROTOR REPAIR REVIEW

Alan C. Robinson, Scott G. Baigent & H. Brett Houston

Progen Ltd, 2/829 Heaphy Terrace, Hamilton 3140

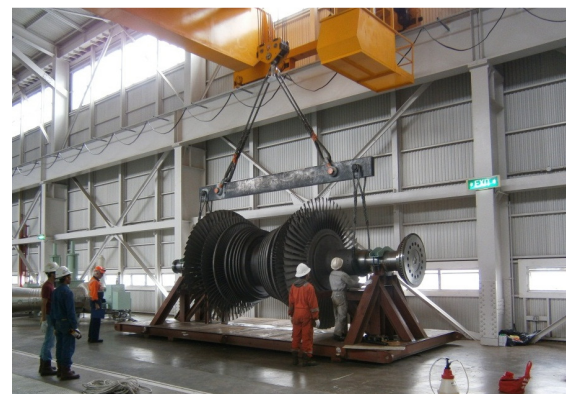
Figure 1 – Turbine Rotor

The rotor was removed in June 2012 and replaced with a new rotor as part of a scheduled overhaul. A picture of the rotor in a maintenance stand is shown in Figure 1. The decision to replace the rotor at the next scheduled overhaul had been made post the

2009 overhaul in conjunction with Fuji (OEM). The decision was based on inspections made on the rotor condition which showed that erosion damage to the rotor had advanced to a point where continued operation could be risking a more catastrophic event such as losing a blade and causing major damage.

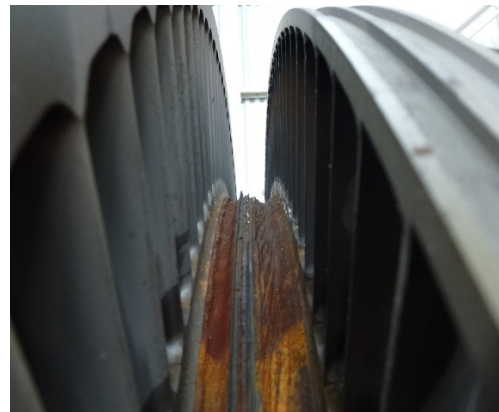
Figure 2 - Erosion at Interstage 3

The major erosion damage to the rotor is located on the rotor body between each of the Reaction Stages. Several of the seal "J" strips in these sections have been eliminated through the erosion of the parent metal surrounding the caulking groove. An example of this erosion at interstage 3 is shown in Figure 2.

The erosion has encroached into the blade support slot at almost all blade locations. Note that the OEM (Fuji) has indicated that the blade support shoulder is critical to the security of the blades.

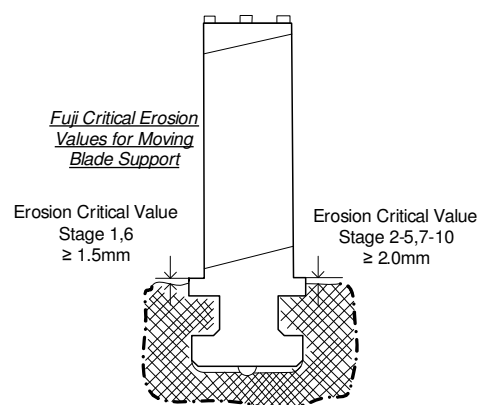
Figure 3 - Erosion at Blade Support Slots

The erosion of the blade support shoulders is most noticeable in the middle reaction stages of each of the flows. This shoulder erosion has progressed since the 2009 overhaul to the point where stages 2-4 and stage 8 were outside the tolerances specified by the OEM (Fuji) as shown in Figure 3.

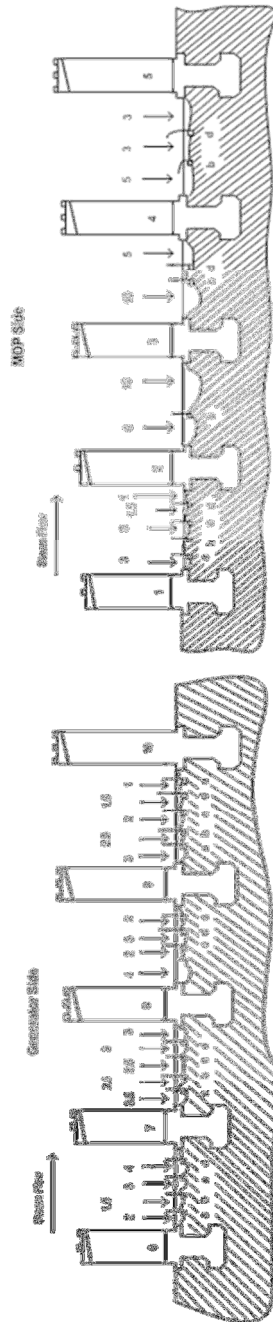
The erosion of the seal areas of the Main Oil Pump (MOP) end section is noticeably more advanced than that of the Generator end as shown in Figures 5 and 6. Of the 18 seal strips that were originally installed at each end of the rotor, only 9 remain in the MOP end whilst 16 remain in the Generator end.

Figure 5 – MOP Side Erosion

Figure 6 – Generator Side Erosion

A notable point with the Generator end is that almost all of the caulking grooves had now been fully exposed on the upstream side. As a result there was a high potential for the seal strip caulking being dislodged in the near future should the rotor be returned to service in its current condition. It was also likely that a number of the adjacent strips may also be dislodged and result in major consequential damage to the blading components.
