# Case study: Modification of Emergency Stop Valve following damage

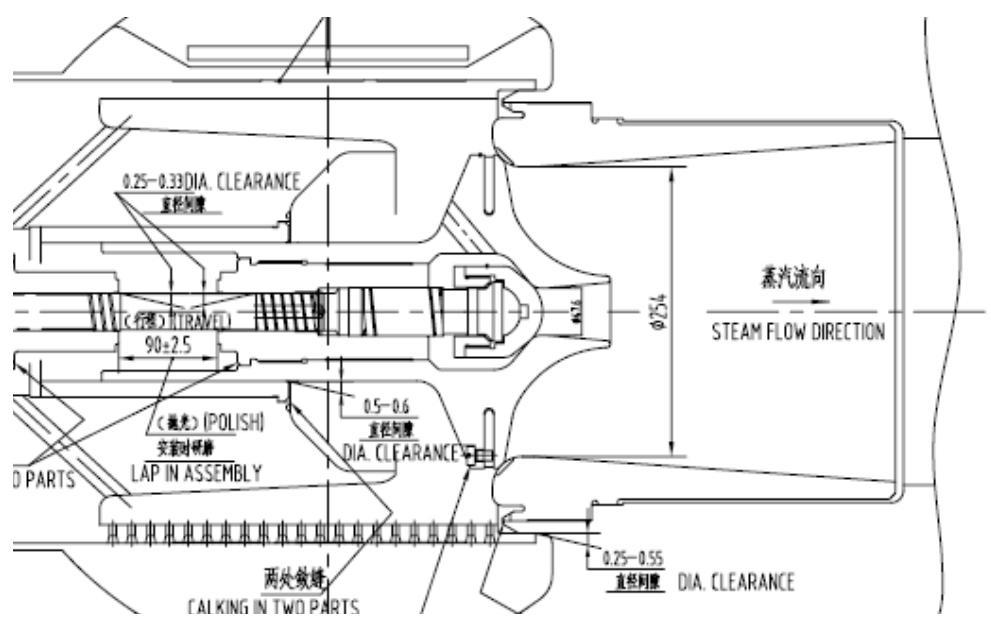
Figure 1: Original design

The OEM Design consisted of a sleeve shrunk fitted into the chest at two shrink fit landings. Landing 1 was on the inlet of the seat and landing 2 along the length of the sleeve after the axial landing that secured the seat in the axial position. The seat was seal/lock welded on the inlet outer diameter to secure it in position.

The design relied on the shrink fit and weld for axial restraint of the seat. The seat did not have a secondary restraint built into the design such that it would be restricted should it come loose. The seat has a relatively thin wall and is directly exposed to the steam. The chest in the area where the seat is located, has a much larger cross section and is also shielded from the steam by the seat.

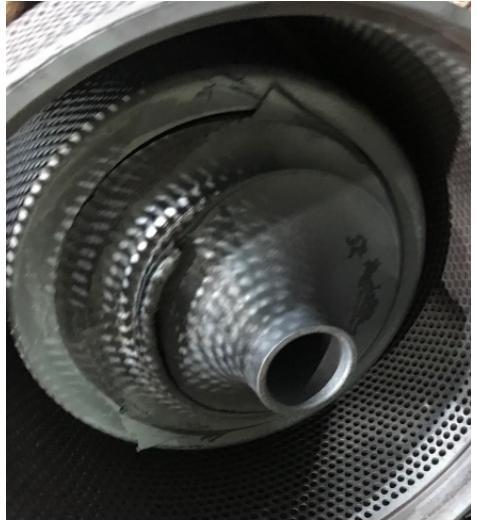
The 320 MW HTC unit was shut down for inspection of the HP Emergency Stop valve (ESV) and Governing valves (GV's) due to restricted valve movement experienced in operation. Upon opening the ESV it was found that the chest seat had come adrift and damaged the spindle seat as well as the steam chest location areas. The seat diffuser section had broken up and pieces went through into the GV's.

Figure 2: Damage to ESV spindle head

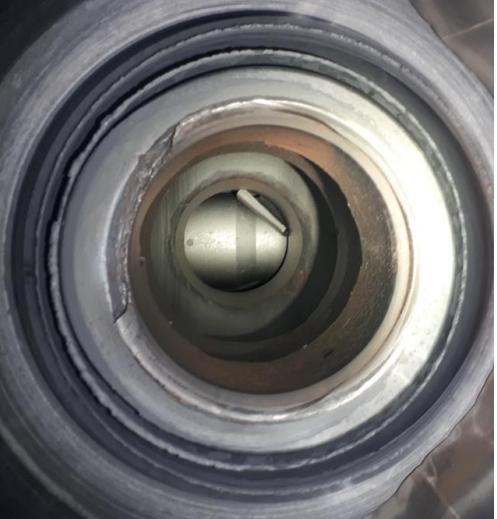
The ESV chest seat moved in the cavity between the valve spindle seat and chest body, severely damaging the location surfaces. Additionally, a crack was found at the rear of the original rear interference fit landing. See Figure 1 for the original design and Figures 2 and 3 for the damage.

Figure 3: Damaged ESV seat in position

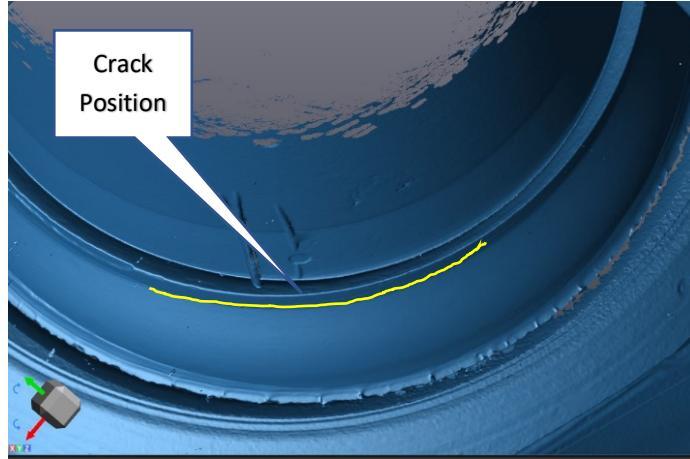
The original design had a radial gap of more than 1mm between the seat at the outlet. This allowed movement and potential for vibration of the seat at the outlet. NDE of valve chest found a crack at the position of the original interference fit landing. The depth of the crack was found to be between 14 and 4 mm, see Figure 4.

Figure 4: Scanned damaged chest with the chest removed Figure 5: Crack in the weld of the LH ESV seat showing the position of the crack

- All damaged material including the crack was machined away for the new seat
- The stress characteristics of the seat is much better than the original due to the geometry of the interface and the fixation bolting

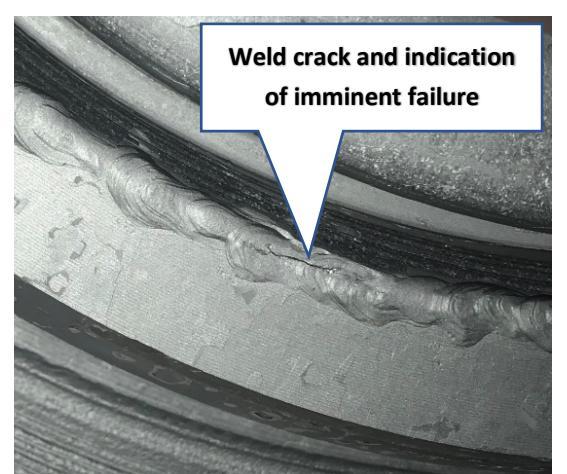
The other ESV on the machine was also opened and the same failure mechanism in an earlier state was identified, see Figure 5.

- Special tooling was designed and build for quick and accurate installation of the new seats
- Due to the improved design the decision was made to replace both ESV seats
