1. Background

The 20MW organic Rankine cycle bi-turbine units were suffering from a higher than expected bearing failure rate. The alignment of the turbines to the generator is considered one of the primary possibilities why the bearings failure rate is higher than expected. The distortion of the turbine structure due to the exhaust pipe movement was suspected as contributor to the bearing failures due to the impact on alignment with the generator.

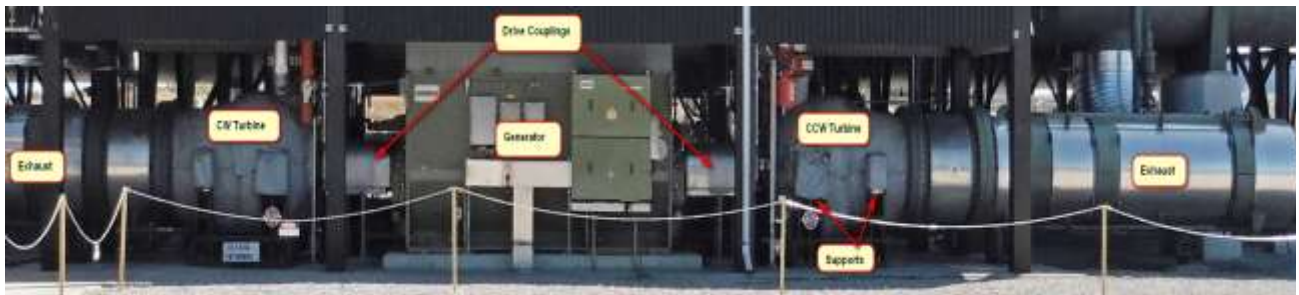
Figure 1: Layout of the unit

Photogrammetry measurement and study were done on one unit to evaluate the movement between the hot and cold conditions. The unit was measured in the hot condition and after shut down it was repeated in the cold condition. Laser alignment measurement results in the cold condition was used as baseline to determine the alignment changes during the transient from cold to hot conditions
