# FLATNESS SURVEY AND CORRECTION OF TURBINE-GENERATOR ALIGNMENT USING LASER MEASUREMENT TECHNIQUES

Michael A. Robinson<sup>1</sup> and H. Brett Houston<sup>2</sup>

<sup>1,2</sup> ProGen Ltd, 2/829 Heaphy Terrace, Hamilton, New Zealand 3240

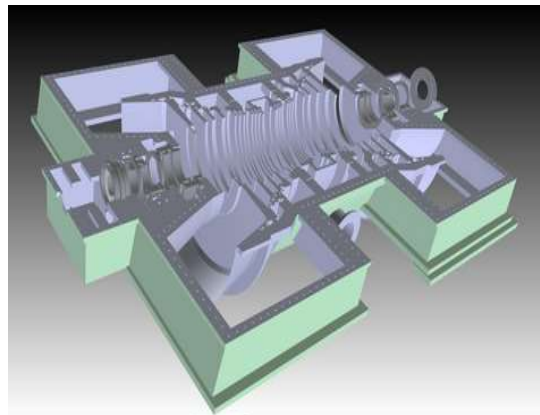
**Figure 1: Representative Image of Lower Casing.**

pedestals. The lower casing rests on the TG plinth on a series of shim packs ranged around the perimeter of the casing. There is a void, or unsupported section, in the centre around the turbine cylinder. The lower casing has an inclination to sag toward this unsupported centre. The weight of the condenser and the vacuum applied by it to the casing may also contribute to this tendency. The casings may also change attitude relative to the generator due to plinth movement.
